DAVID EVANS
AND ASSOCIATES INC.

September 2, 2009

SUBJECT: COURTHOUSE SQUARE QUARTERLY BUILDING-MONITORING PROGRAM

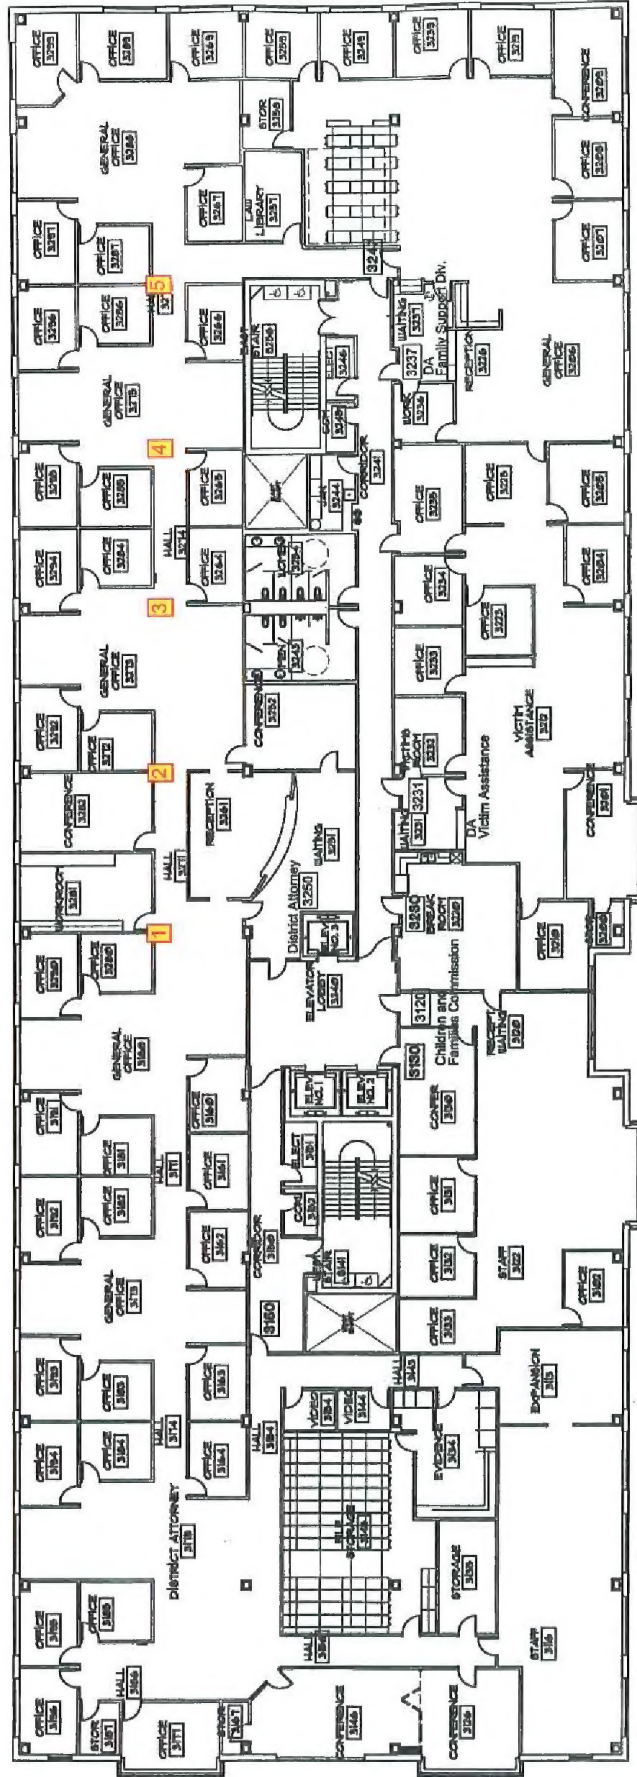
CS-3

3rd Floor Location	Nov. 24, 08 Deflection (in.)	Aug. 31, 09 Deflection (in.)	Δ Deflection (in.)
1	1.3	1.4	0.1
2	1.9	2.1	0.2
3	1.4	2.1	0.7
4	2.8	2.4	-0.4
5	2.1	2.1	0

Note: Positive Δ deflection indicates increase in deflection

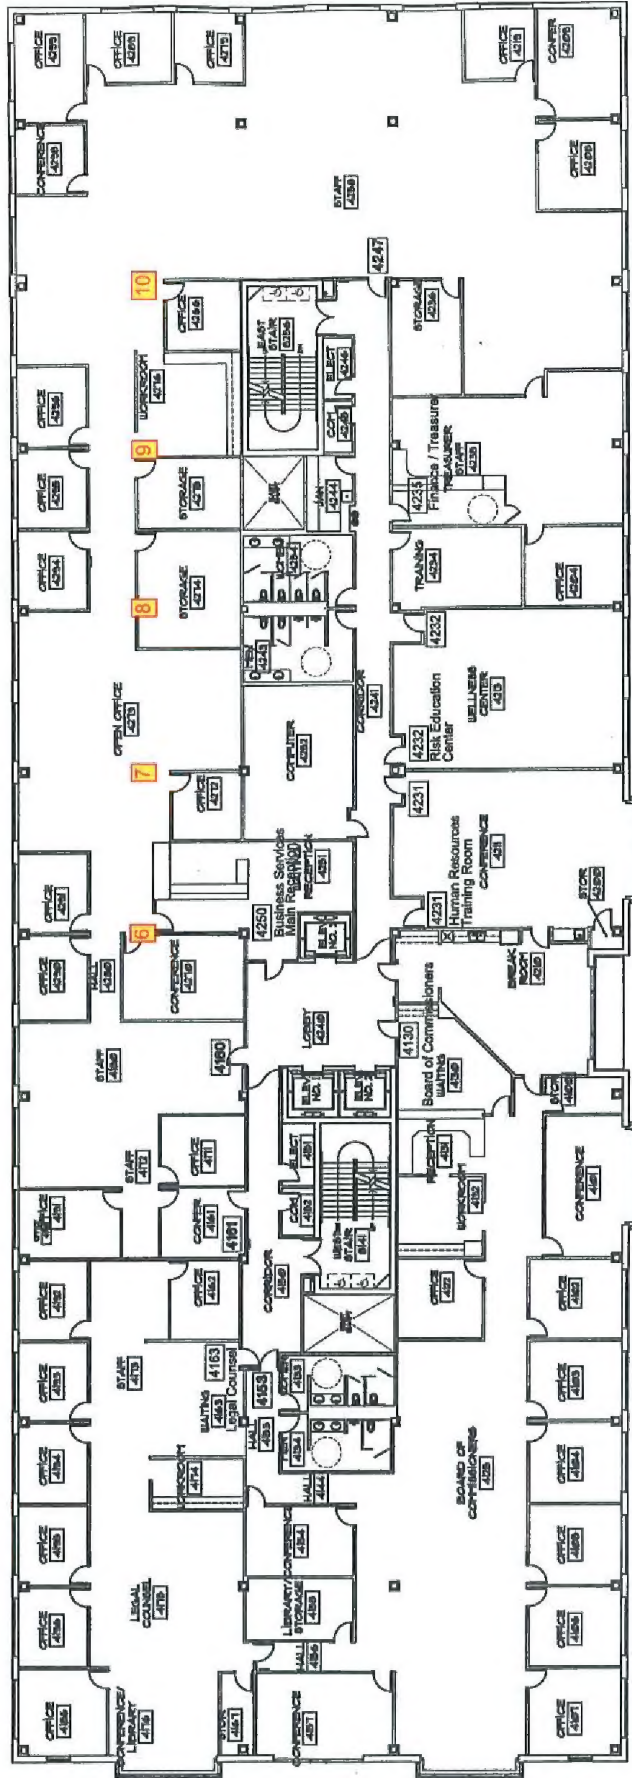
CS-4

4th Floor Location	Nov. 24, 08 Deflection (in.)	Aug. 31, 09 Deflection (in.)	Δ Deflection (in.)
6	1.3	1.2	-0.1
7	1.4	1.3	-0.1
8	1.5	1.7	0.2
9	2.2	2.2	0
10	2	1.5	-0.5

Note: Positive Δ deflection indicates increase in deflection

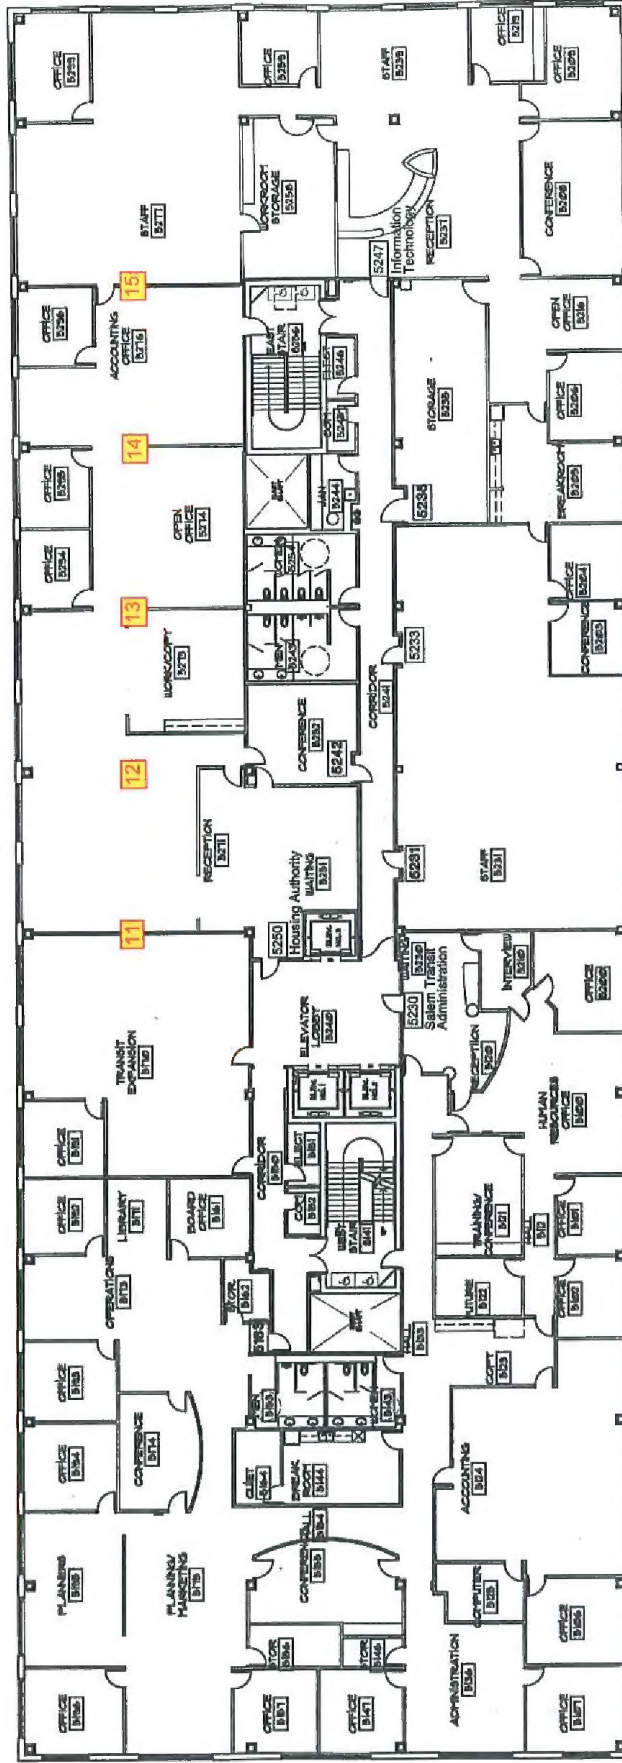
CS-5

5th Floor Location	Nov. 24, 08 Deflection (in.)	Aug. 31, 09 Deflection (in.)	Δ Deflection (in.)
11	1.9	2	0.1
12	2.2	2.3	0.1
13	1.7	2.2	0.5
14	3.2	3.5	0.3
15	2.9	2.5	-0.4

Note: Positive Δ deflection indicates increase in deflection
